A&A Works Project on B/F to 1/F, United Plaza 135-145 King's Road

Presented by:
Associate Director – Samson Chu

- **Project Address:**
 - B/F, G/F, M/F & 1/F
 - United Plaza in United Building (民眾大廈)
 - 135-145 King's Road
 - Around 44 year Building Age
- Site Area (Approx.) : 0.08 hectares (approx.)
- G.F.A.(Approx.): 2,780 m²
- **Project Duration:**
 - Planning on 2011
 - Completed on 18 May 2016
 - (BA14 Acknowledgement)

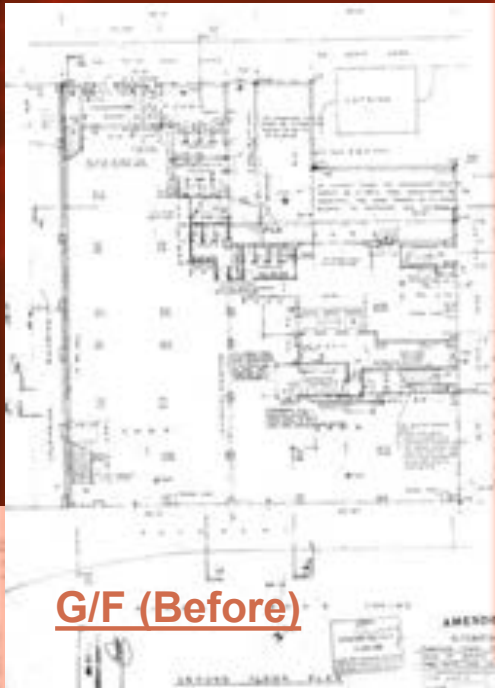
G/F (Before)

- No lift access from B/F-1/F.
- Insufficient staircase for means of escape for M/F, 1/F to apply for restaurant licenses

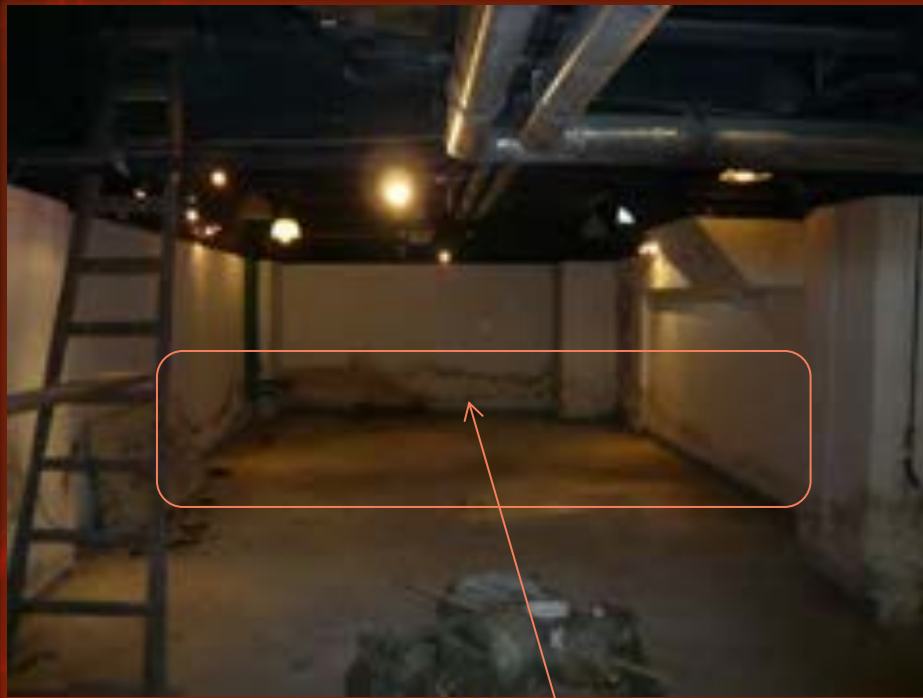
- Water Seepage found at basement due to high ground water level

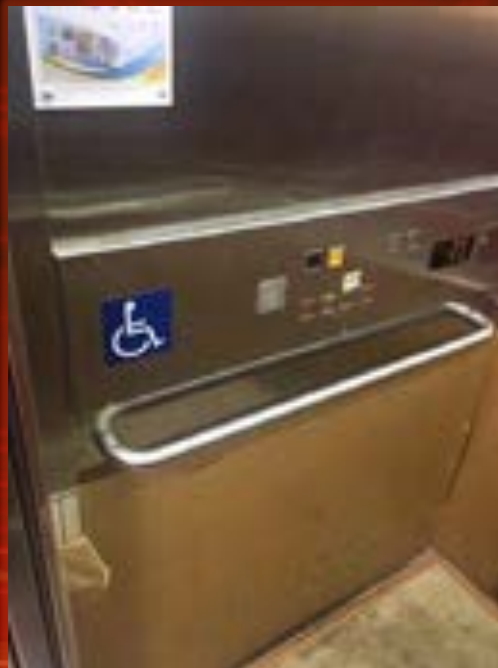
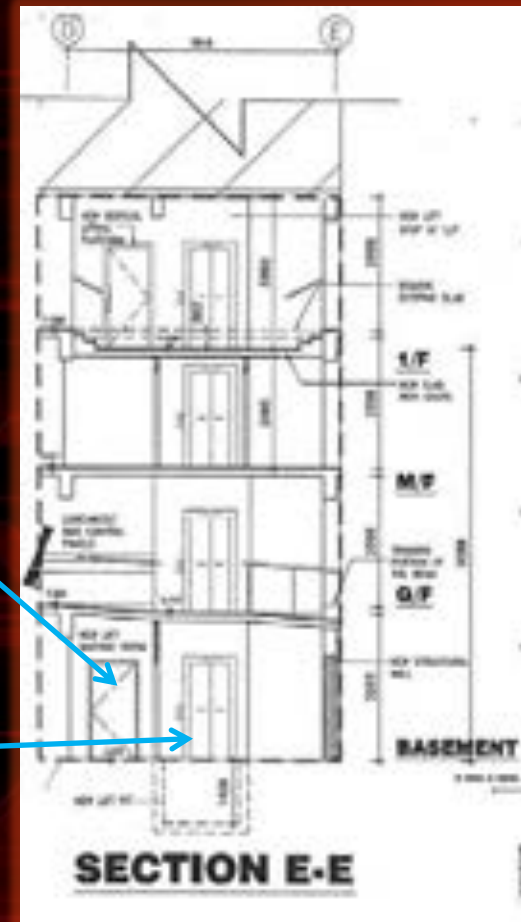
Vertical Access Section (After)

Difficulties	Solutions & Professional Input
Overrun of lift on 1/F leading the lift landing can only up to lowered 1/F lift landing and no extra headroom for lift machine room	Enhancement of vertical access by means of traction lift and provision of lifting platform from M/F to 1/F to solve lift overrunning problem. Machine room was provided on B/F to solve headroom problem.

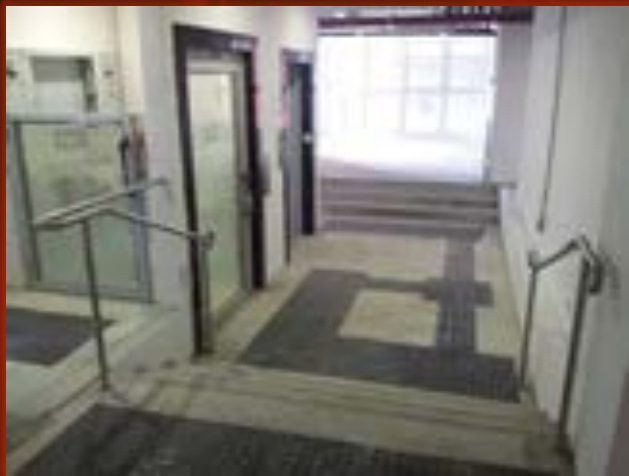
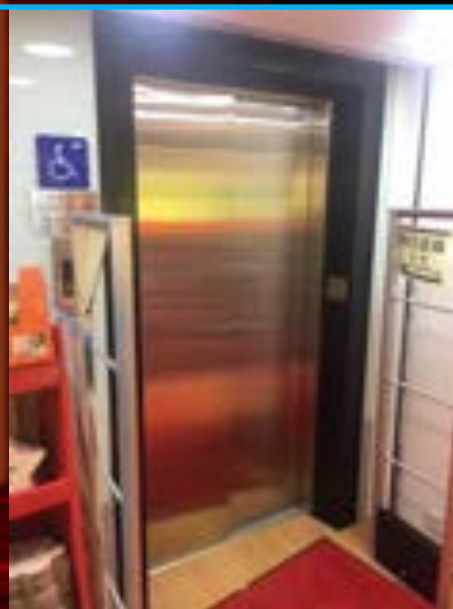
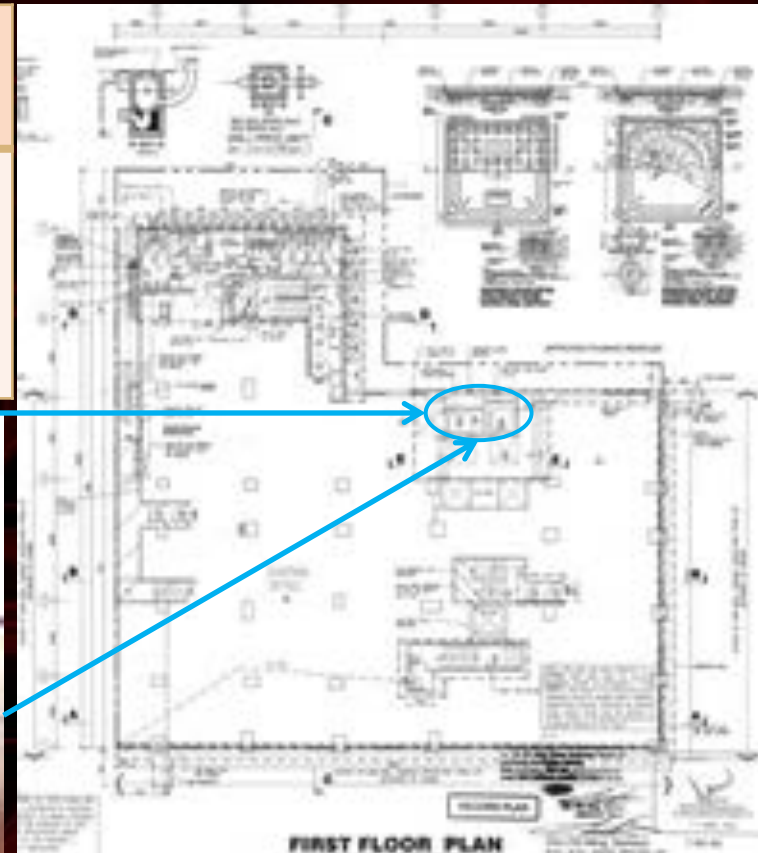
1/F A&A Plan (After)

Difficulties	Solutions & Professional Input
Overrun of lift on 1/F leading the lift landing can only up to lowered 1/F lift landing and no extra headroom for lift machine room	Enhancement of vertical access by means of traction lift and provision of lifting platform from M/F to 1/F to solve lift overrunning problem. Machine room was provided on B/F to solve headroom problem.

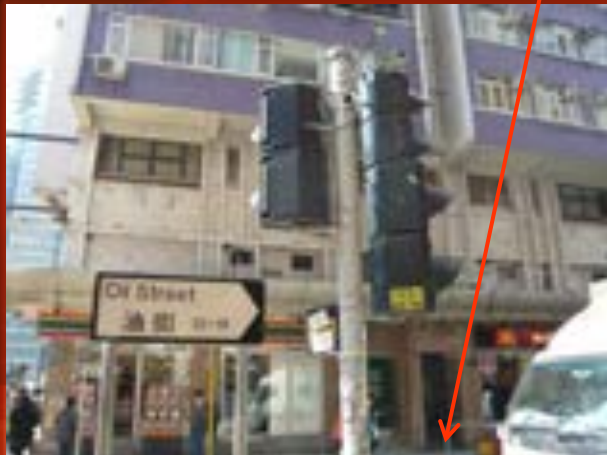
The mean access to 1/F from Oil Street entrance (Before A&A)

No independent access staircase for basement, where access to basement was by means of internal staircase inside ground floor shop. The access staircase to 1/F from Oil Street was not attractive as compared with facing King's Road.

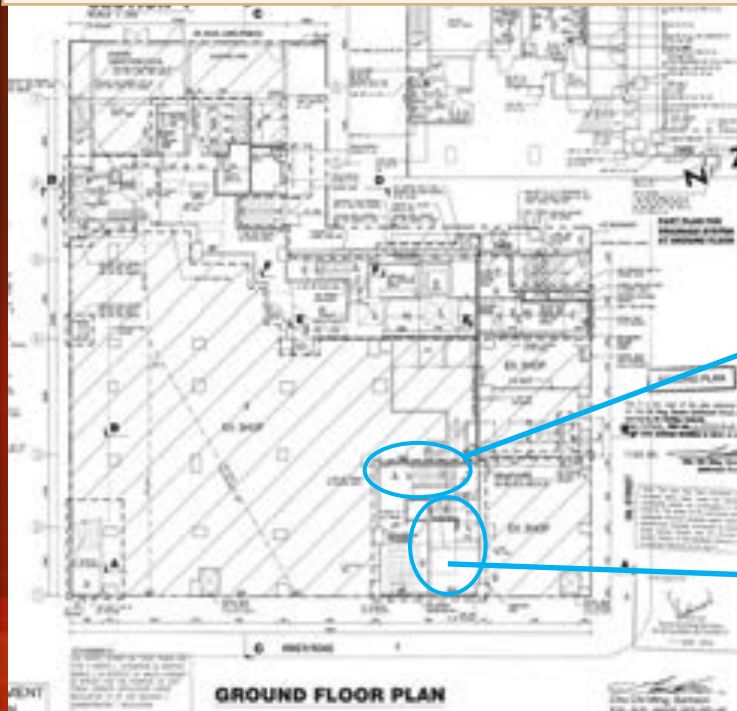
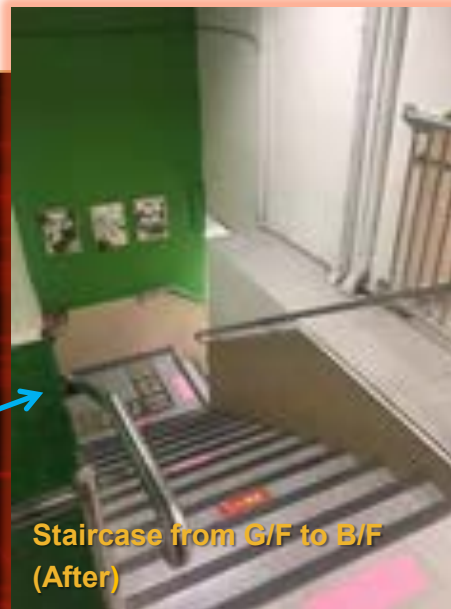
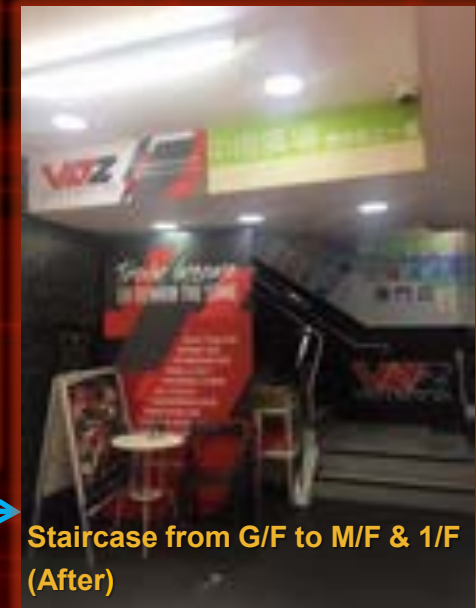
G/F A&A Plan (After)

Provision of access staircase facing King's Road on G/F and separated from shop area which lead to B/F and 1/F to enhance accessibility.

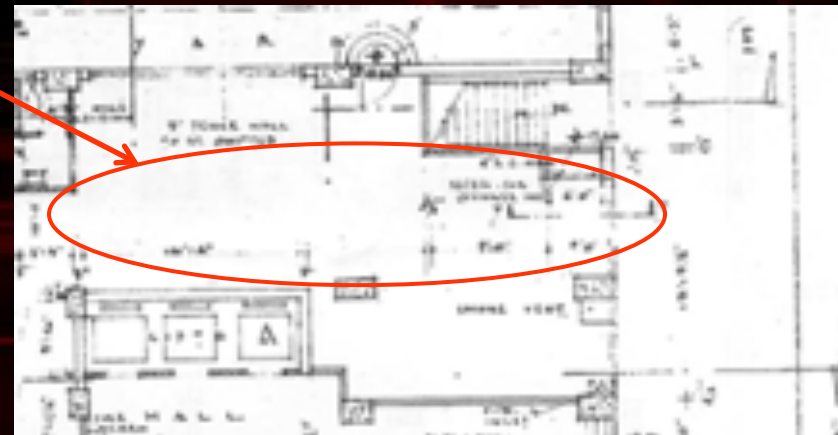
G/F Plan (Before A&A)

No Barrier Free Access entrances provided on G/F, which shall be accessible to public street.

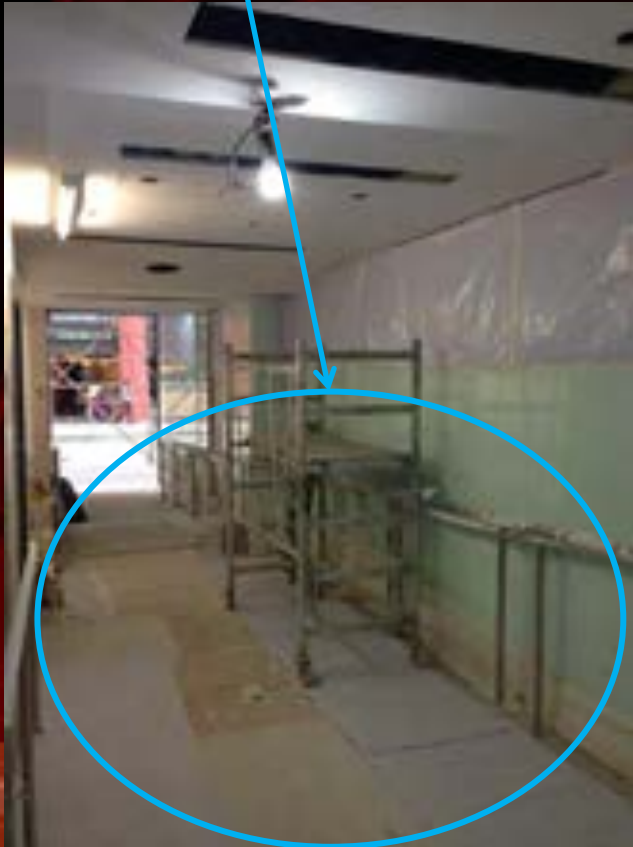
G/F Plan (After A&A)

Provision of new accessible ramp at entrance facing Oil Street connected to new lifting platform

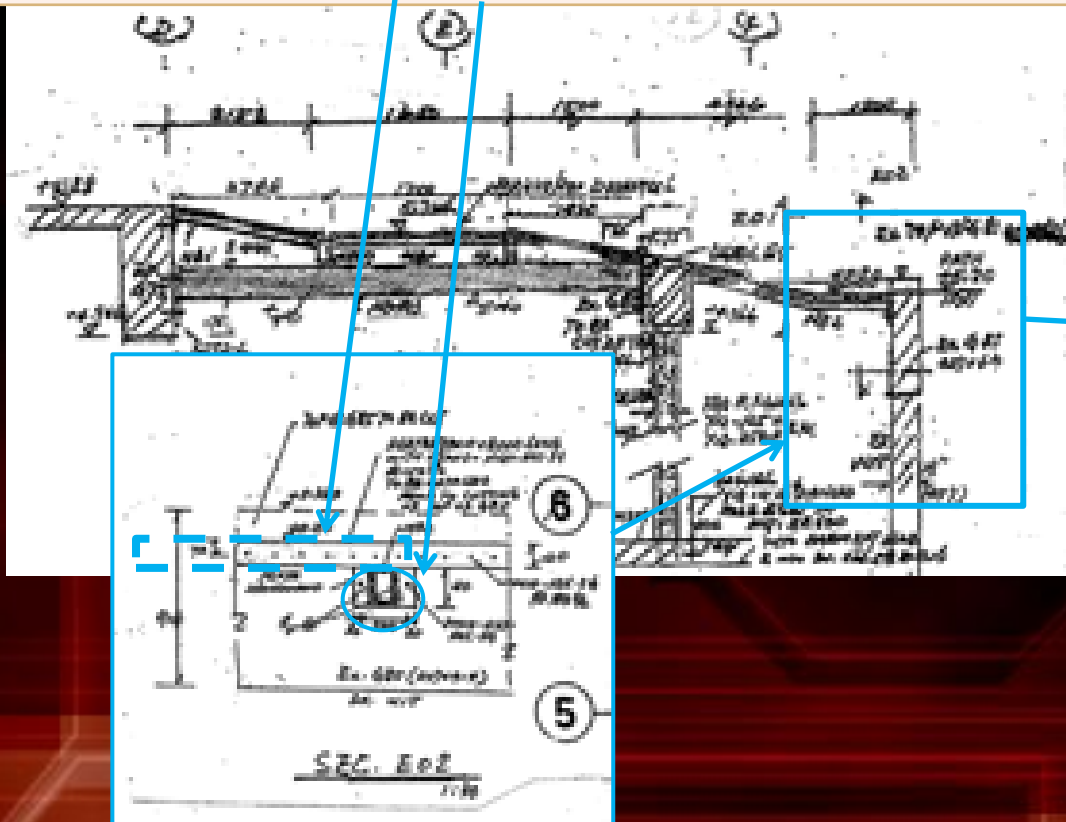
G/F Framing Plan (Before A&A)

- Cutting portion of ground beam
- Structural strengthening by steel plate

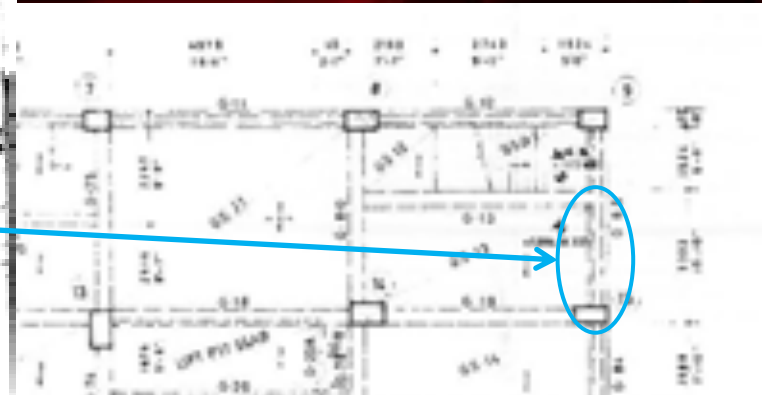
Sections of New Accessible Ramp on G/F (After A&A)

Provision of new accessible ramp at entrance facing Oil Street connected to new lifting platform

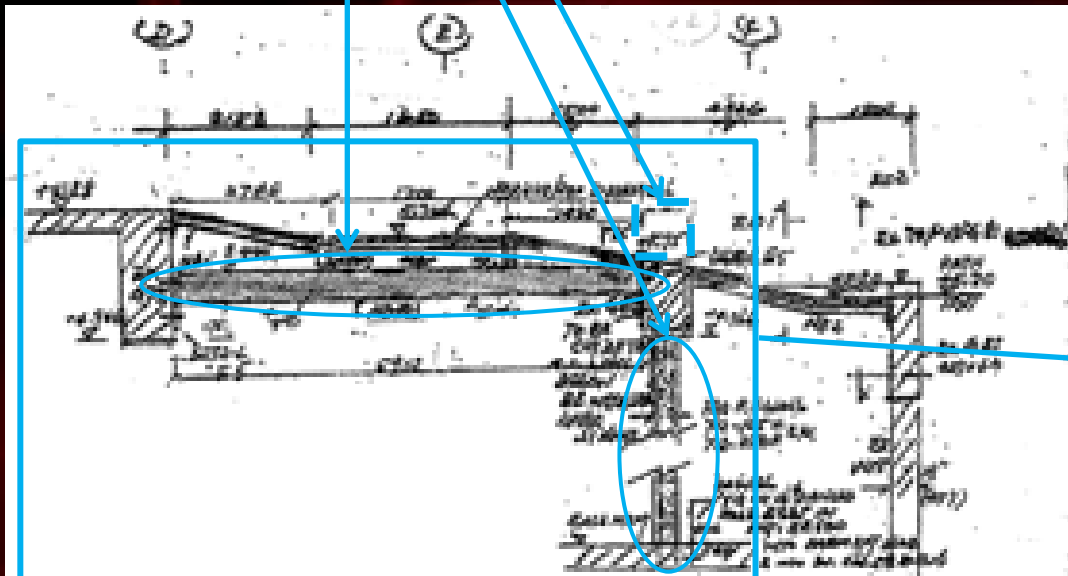
Section of New Accessible Ramp on G/F (After A&A)

Provision of new accessible ramp at entrance facing Oil Street connected to new lifting platform

- Cutting portion of ground beam
- Erection of new structural wall
- Erection of new steel channel

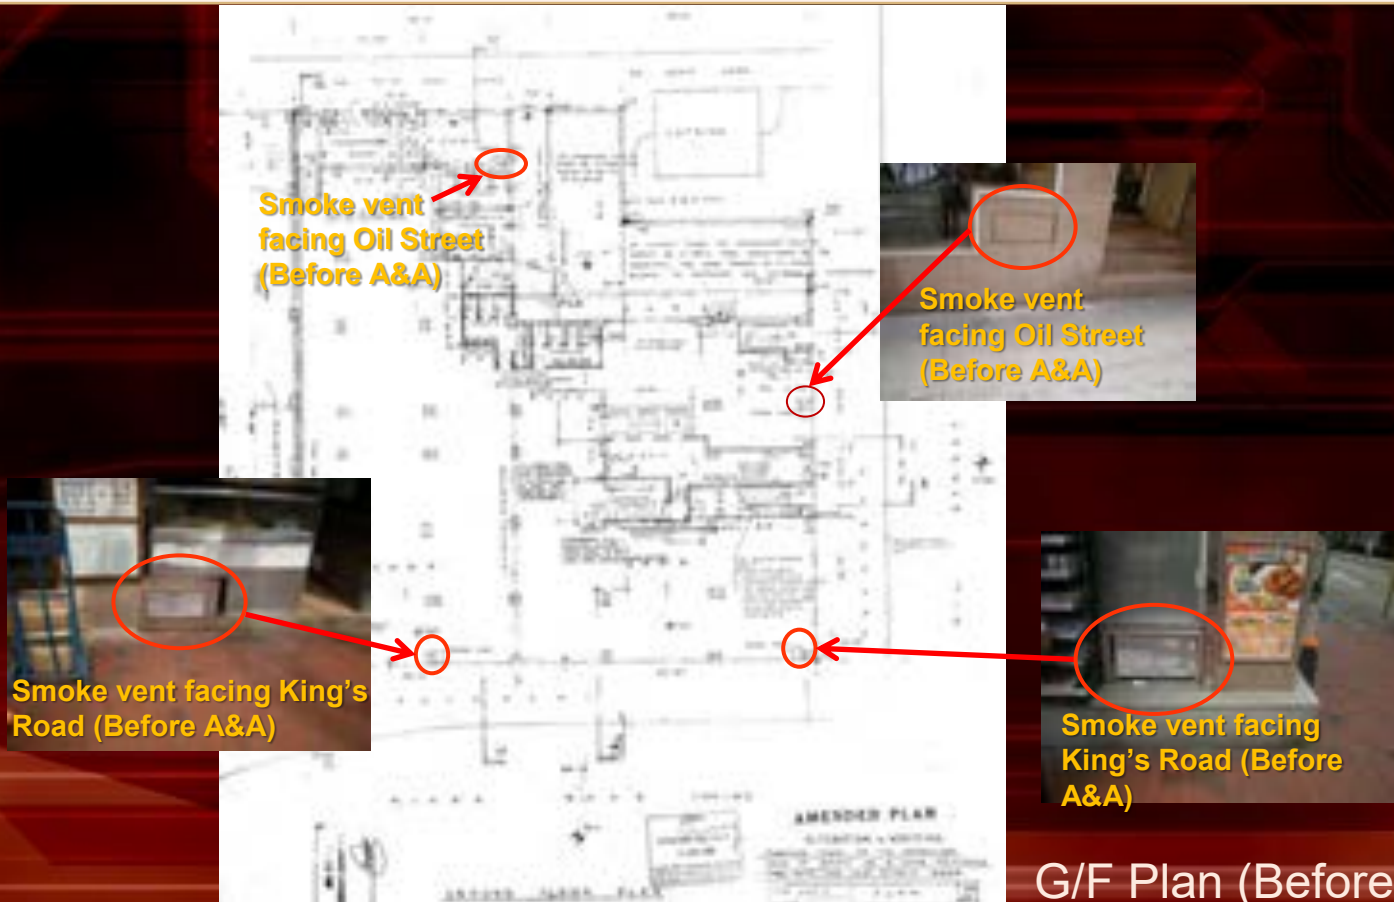
G/F Plan (Before A&A)

Inadequate provision of smoke outlets for basement level:-

- The aggregate area of smoke outlets serving the basement level is insufficient

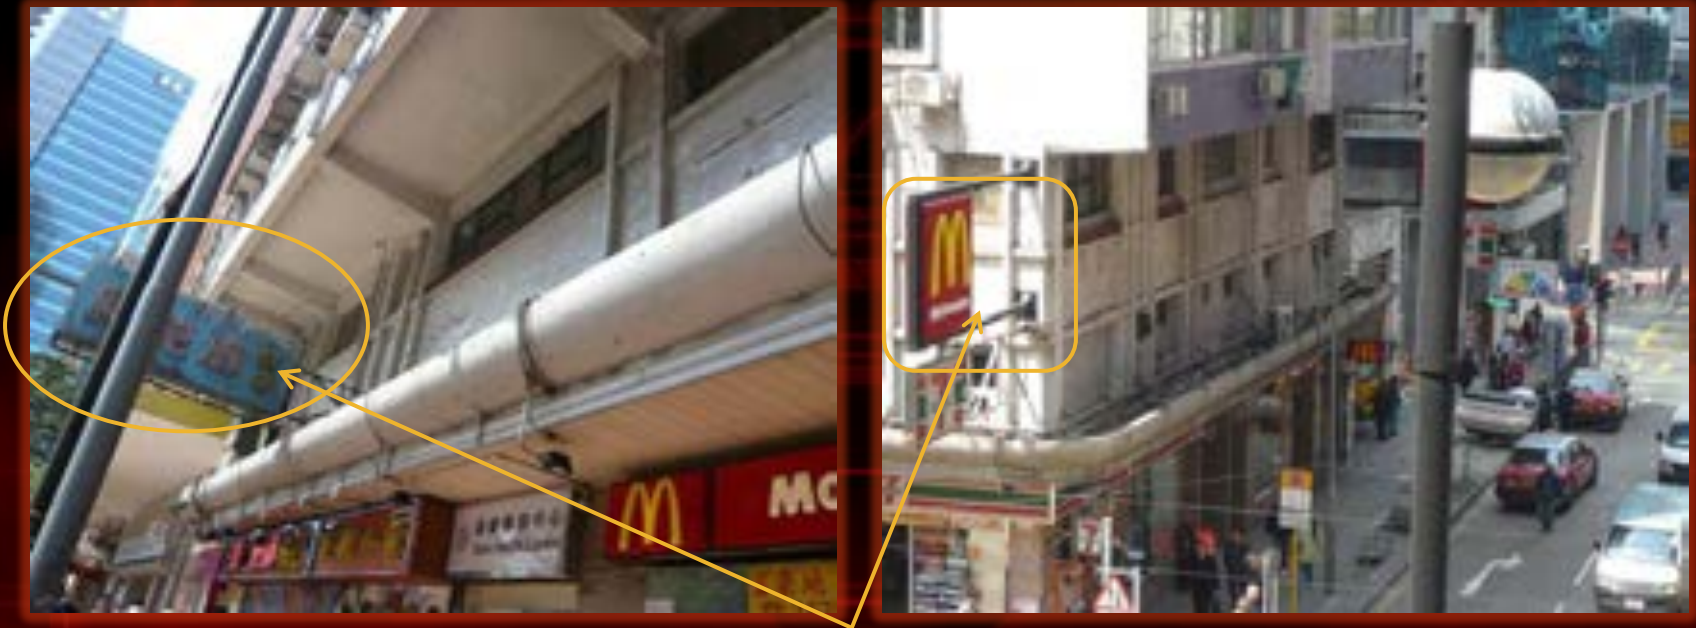
King's Road to Oil Street old projecting signboards (Before A&A)

Only two projecting signboard was erected facing King's Road and Oil Street.
The rest of frontage of commercial podium was wasted.

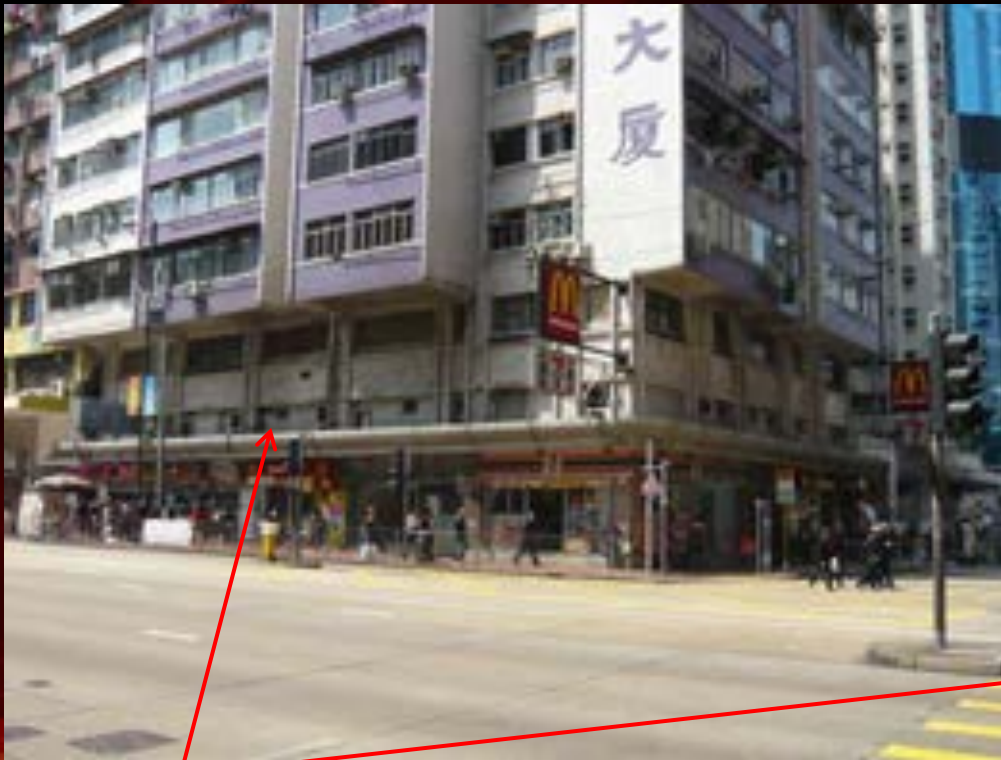
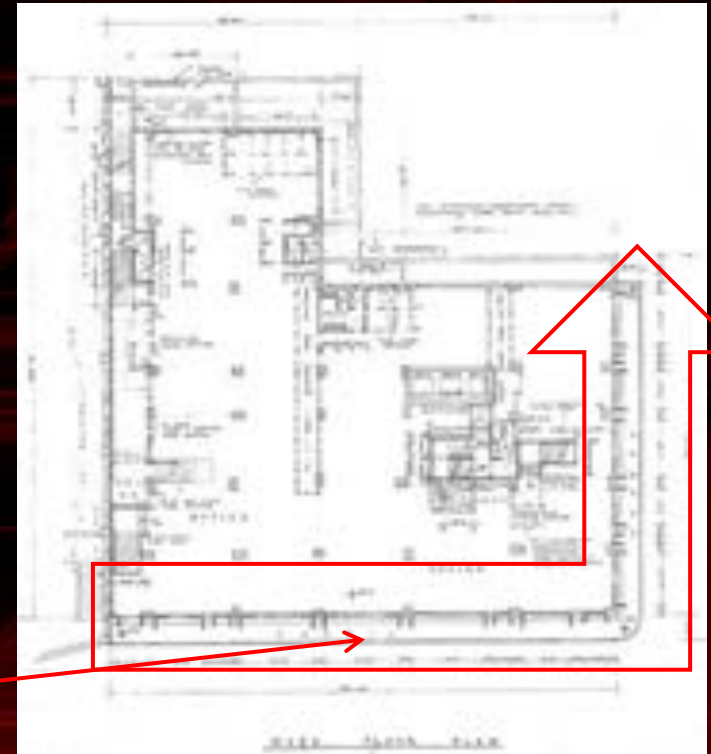
The canopy facing King's Road and Oil Street obstructed the view of pedestrian to look up for M/F and 1/F commercial floors.

Old canopy attached on M/F level obstructed the view of pedestrian
(Before A&A)

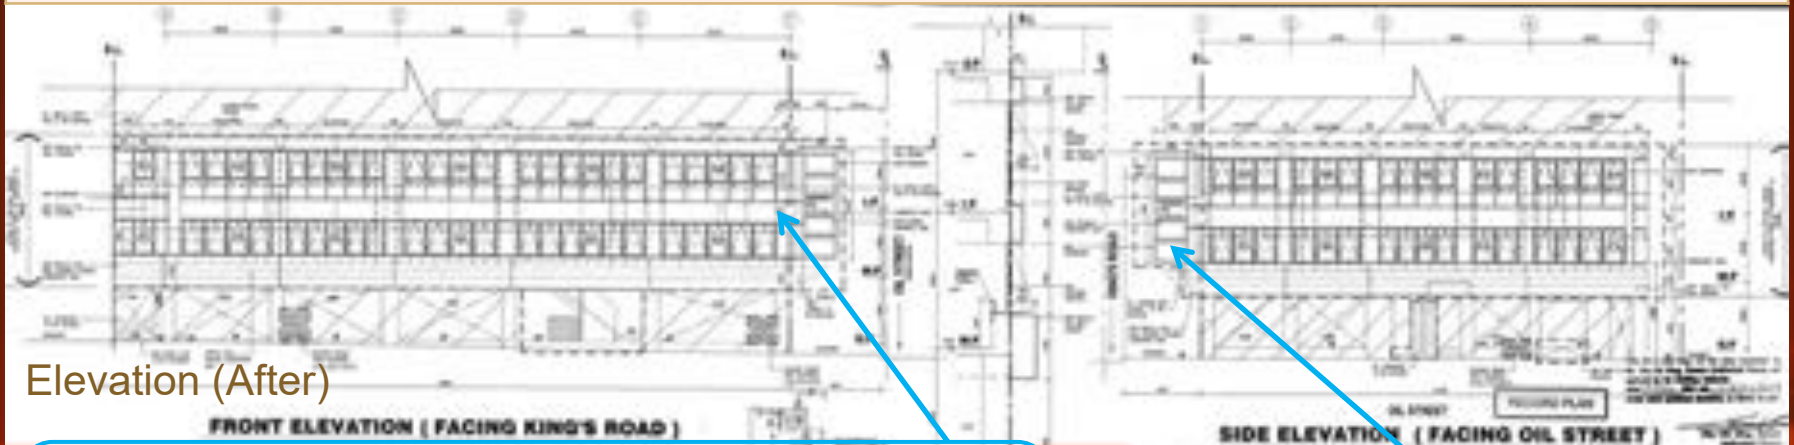
Elevation (After)

Canopies along King's Road and Oil Street were removed for eye catching of M/F & 1/F outlook.
Provision of windows enlargement on M/F and 1/F and wall signage

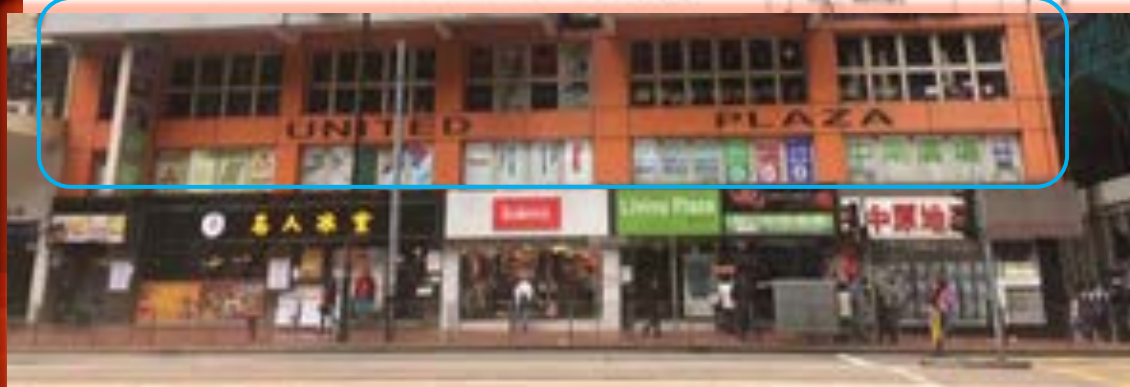
Front View (Facing King's Road) Removed Canopy and Enlarged window with wall signs (After A&A)

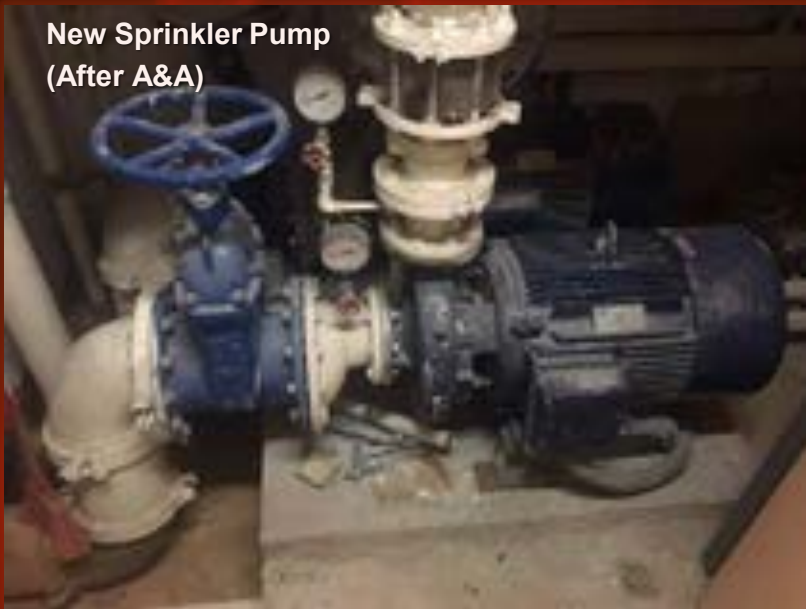
Applied exemption from Fire Services Department (FSD) for omission of generator set and provision of fast response type sprinkler head on 2/F and 3/f staircase

**New Sprinkler Pump
(After A&A)**

No sprinkler provided to G/F – 1/F and existing FS tank only have approximate 19 m3.

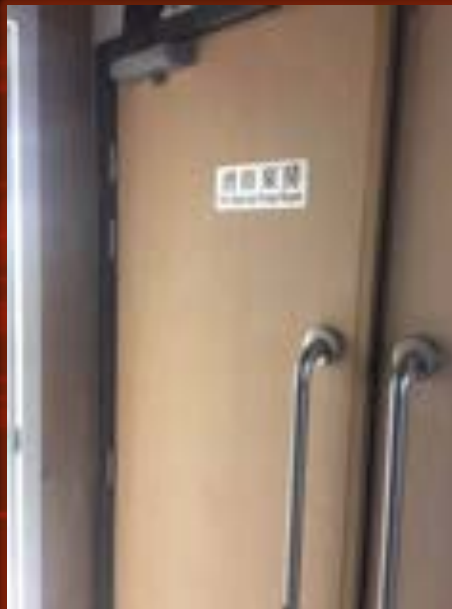
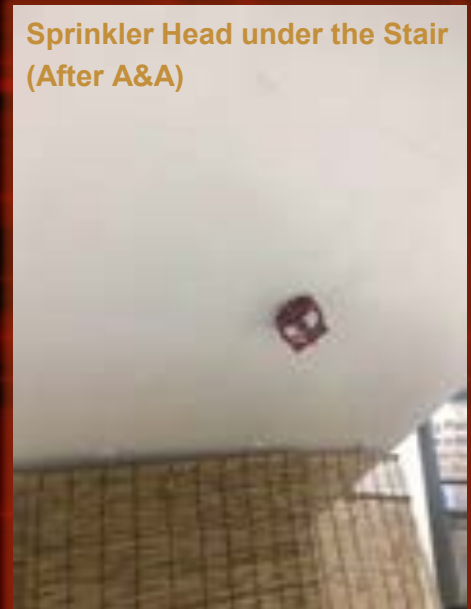
**Sprinkler Head under the Stair
(After A&A)**

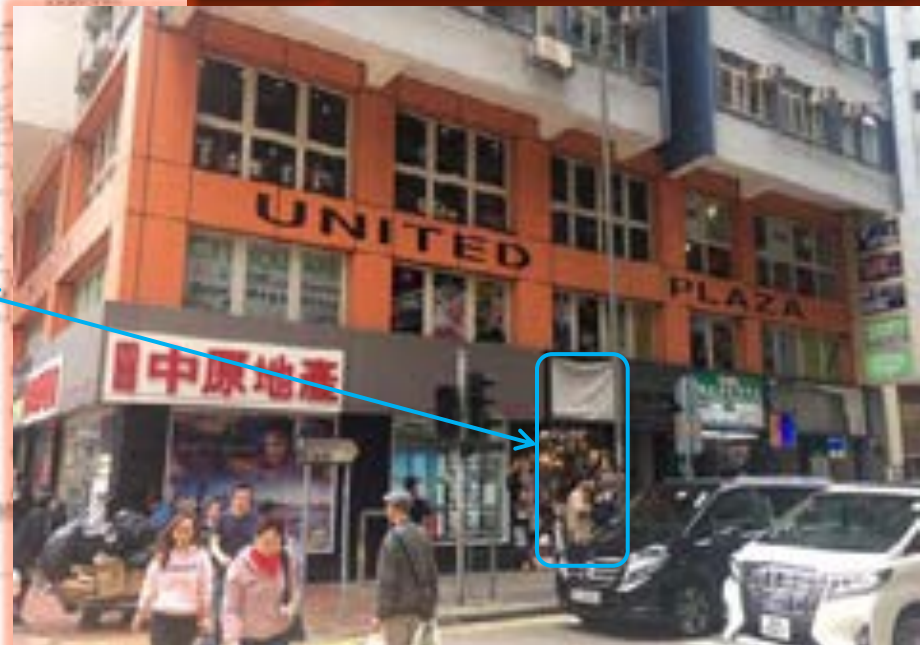
B/F A&A Plan

Provision of pump services with underground water pump pit to solve flooding problem in B/F

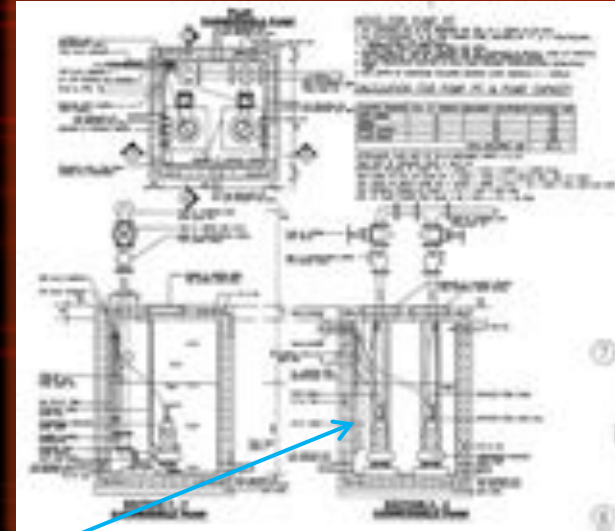
New Submersible Pump Sectional Details

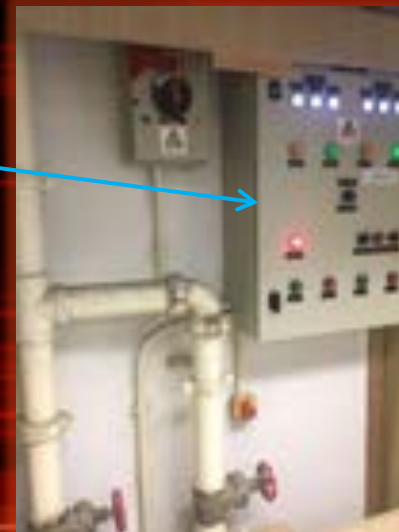
New Submersible Pump
Control Panel
